**K C Engineering Ltd**  
[www.kceng.com](http://www.kceng.com)

**Technical Report 07- 015**

**Subject: CHALMERS BOND STRENGTH TESTING OF STEEL ROLL NECK  
BUSH IN ACCORDANCE WITH ISO 4386-2:1982**

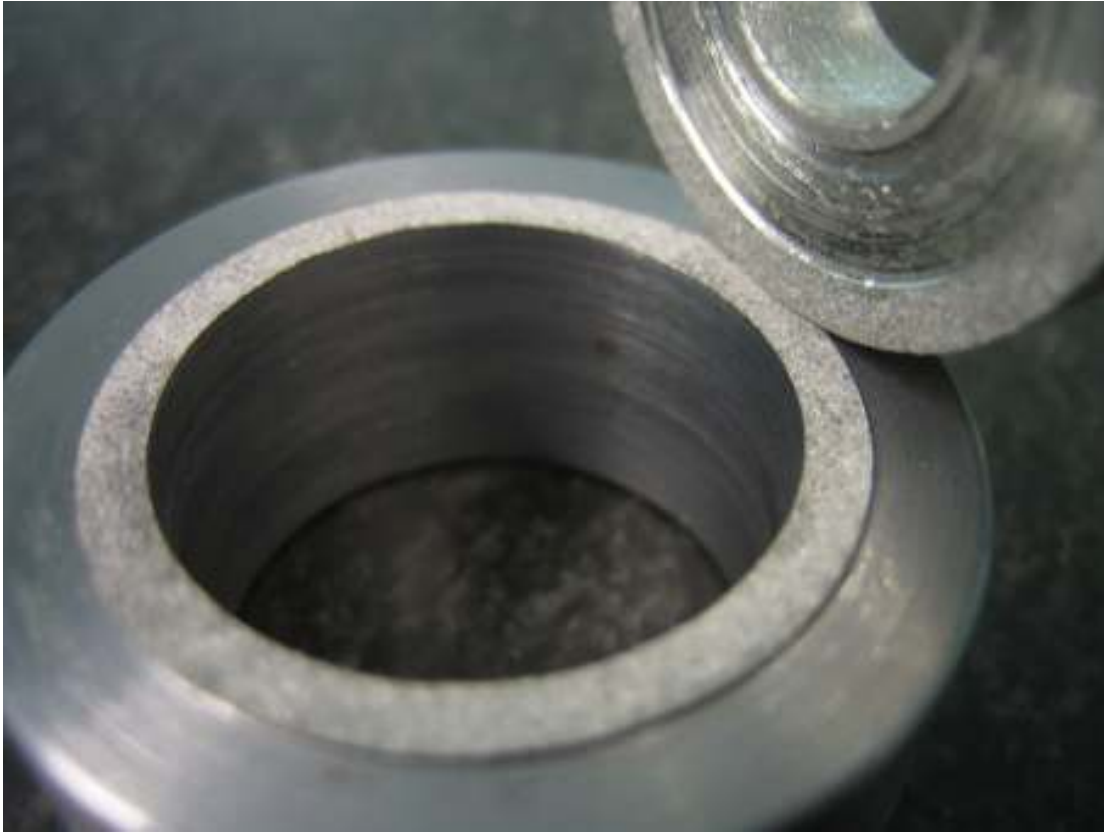
3. The fracture in each test piece had occurred in the bond surface/whitemetal with no evidence of defects such as lack of bond or porosity.

Figure 1: Test piece showing fractured area
